BULB MAINTENANCE AND TROUBLESHOOTING

System maintenance is critical to long bulb life. Shown below are some bulb failure modes and their solutions.

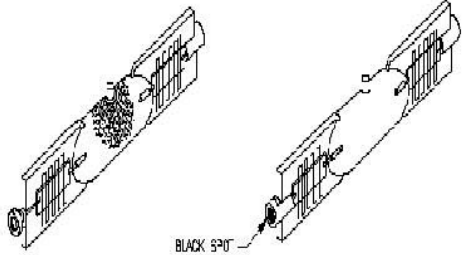
Cause: Over cooling is generally caused by too much airflow past a bulb, which results in rapid degradation of the bulb, due to deposition of plaque on the quartz.	
Solution: Order the DYMAX Temperature Control Kit.	
Arcing indicated by a gold, brown or black spot on the ceramic ends of the bulb
